Subject: Dam Inspection Report for Clarks Lake Dam, Field File No. 58.03, Dam Key Sequence No. 1189, Door County

This is the Department of Natural Resources' Dam Safety Report based on our inspection of the Clarks Lake Dam on 8/14/2009. The site inspection was performed based on a dam safety concern from the President of the lake association. This report identifies work that you are required to do on the dam and a schedule for when that work is to be completed. Please contact me if you have questions about the needed repairs or are uncertain how to proceed.

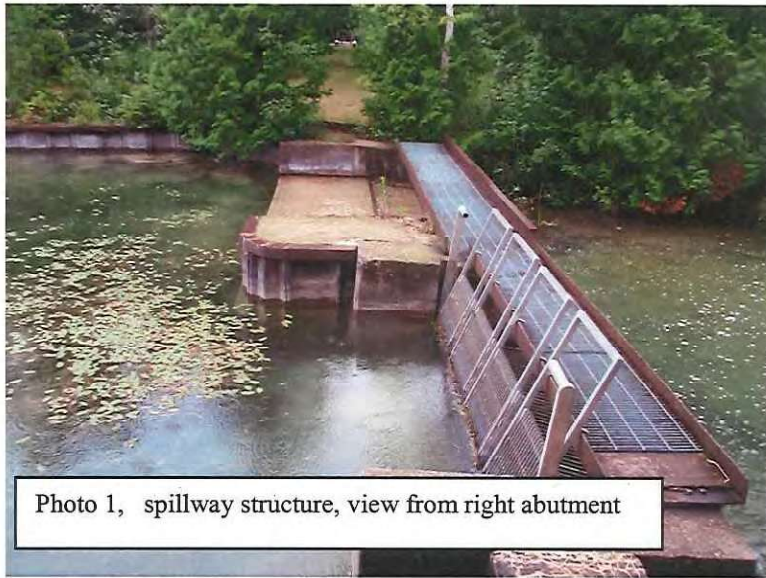
The dam consists of a poured-in place concrete spillway structure with a stop log section on the right side and a fixed crest section on the left side. The structure is flanked on each side by earthen embankments and reinforced with steel sheet piling. A metal bridge provides access to each side of the embankment. Photo 1 is view of the dam spillway structure from the right abutment.

Trees and brush were noted growing on both the right and left embankments near the concrete abutments and steel sheet piling. Photo 1 shows the left side of the dam and the trees that need to be removed. Photo 3 shows a portion of the vegetation that needs to be removed along the right embankment.

Photo 1, spillway structure, view from right abutment

Tree removals and removal limits were discussed with Mr. Dan Woelfer (Town of Sevastopol) during the inspection. All the trees and brush within 10 feet of the dam right and left side abutments are to be removed. Tree removal is to include the complete removal of the stumps and the roots, filling of the holes created with firmly compacted tight soils, adding topsoil and grass seed to establish grass growth. I have included our Fact Sheet on "Vegetation Control on Dams" for your information.

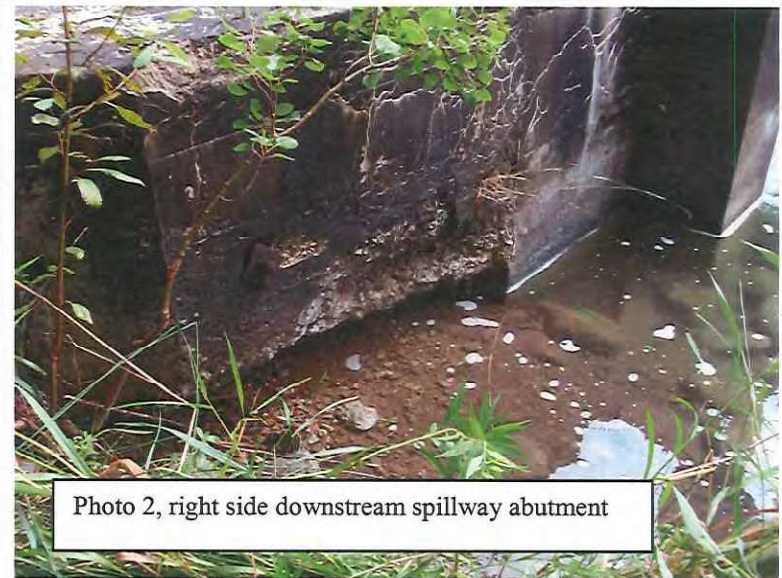
The concrete portions of dam appear in fair condition. However, the right side of the spillway abutment is experiencing undermining due to deteriorating concrete and the stream currents on the downstream side of the spillway. Please have your engineer inspect the right abutment of the spillway structure, review the overall condition of the existing concrete, and provide a recommendation for the repairs. Findings as a result of your engineer's investigation shall be submitted to the Department for our files.

Plans and specifications for the repairs shall be submitted to the Department for review and approval prior to repair or reconstruction. Photo 2 is a downstream view of the right abutment showing the undermining that has occurred and the concrete that has been lost.

Photo 2, right side downstream spillway abutment

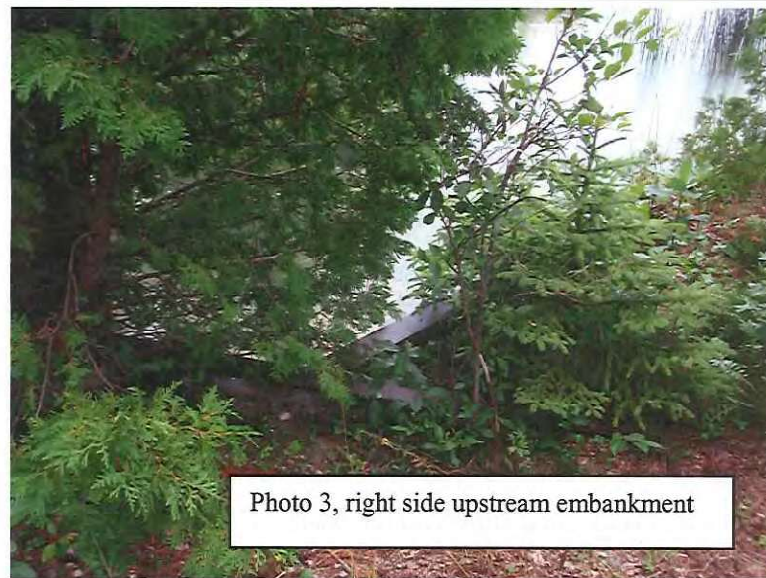
Photo 3, right side upstream embankment

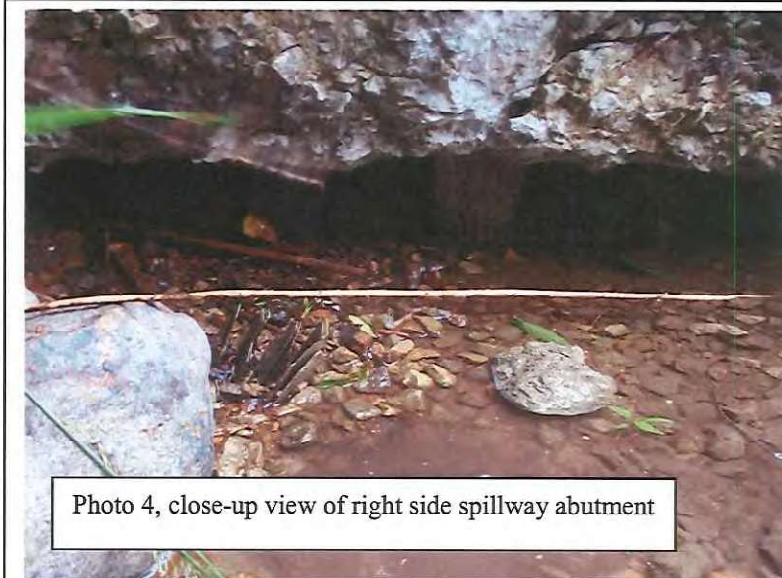
Photo 4, close-up view of right side spillway abutment
